MOLD ASSESSMENT REPORT & REMEDIATION PROCESS OF:

**1190 Bay Drive
Miami Beach, FL 33141**

Report Date: 04/18/18

PREPARED BY ALBERTO RIVERA & MIAMI MOLD SPECIALIST

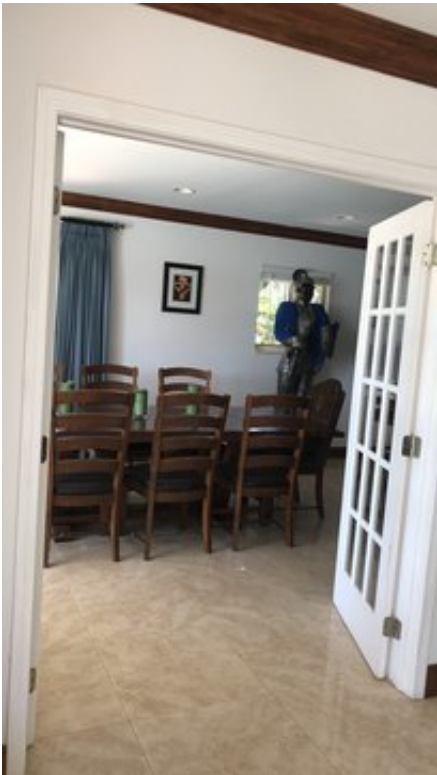
Shows the dining room upon inspection.

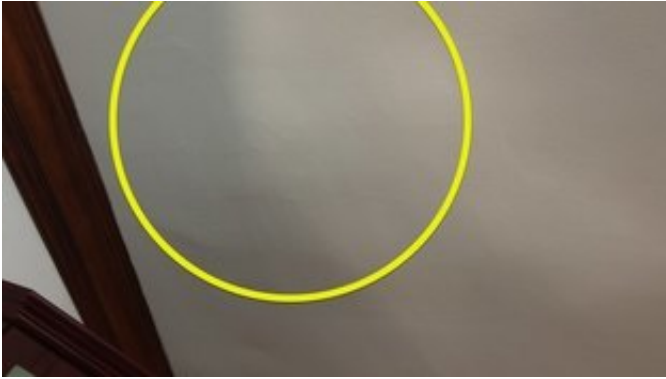
Shows discoloration as well as paint peeling, cracking and/or bubbling evident of water damage around the ceiling of the dining room.

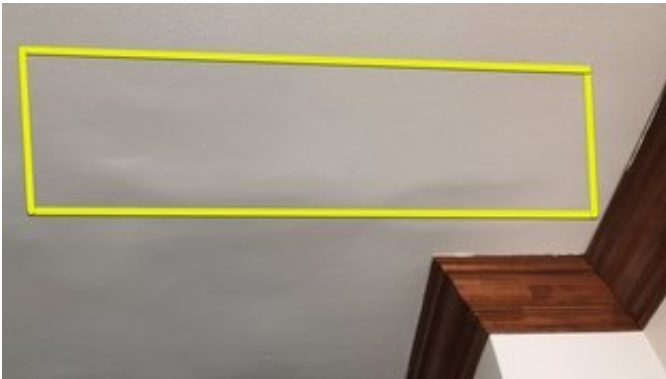
Shows discoloration as well as paint peeling, cracking and/or bubbling evident of water damage around the ceiling of the dining room.

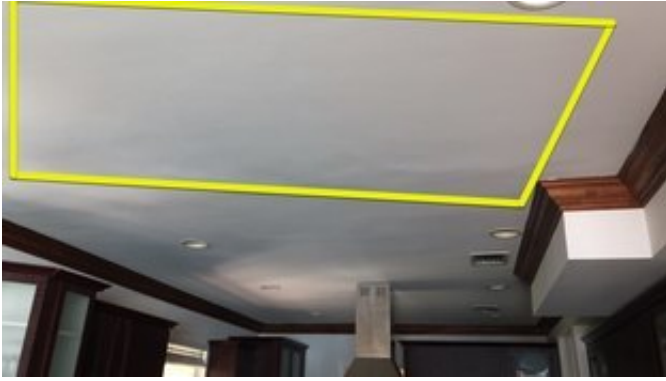
Shows discoloration as well as paint peeling, cracking and/or bubbling evident of water damage around the ceiling of the dining room.

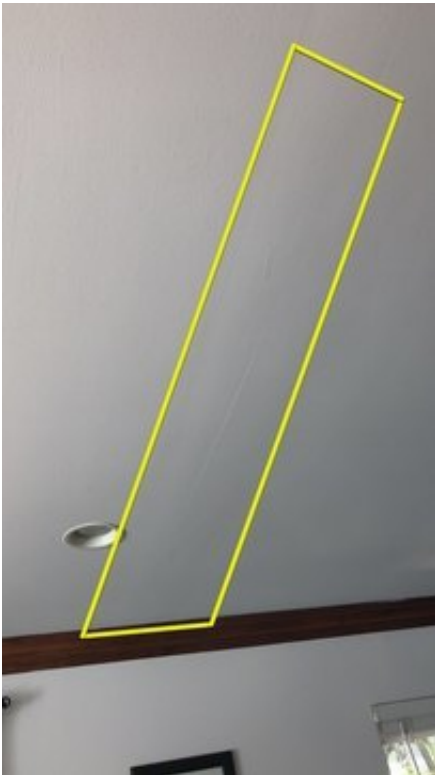
Shows discoloration as well as paint peeling, cracking and/or bubbling evident of water damage around the ceiling of the dining room.

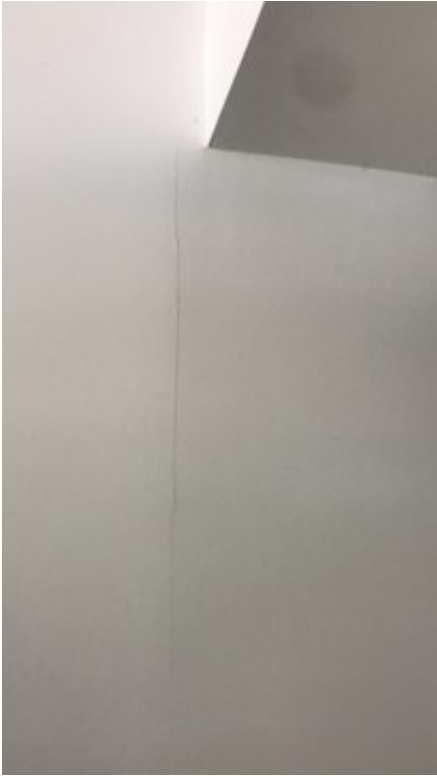
Shows discoloration as well as paint bubbling evident of water damage on the living room wall.

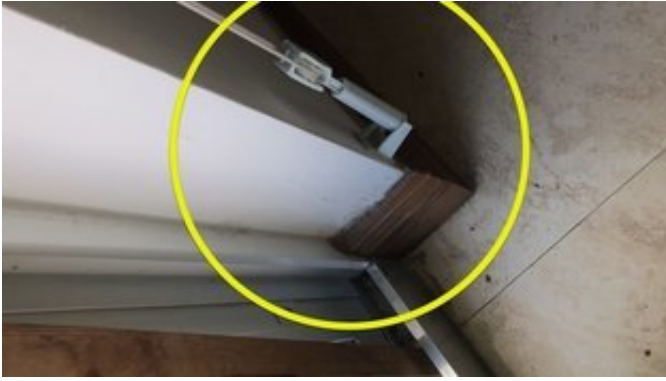
Shows discoloration as well as paint peeling evident of water damage on the bottom portion of the living room baseboard.

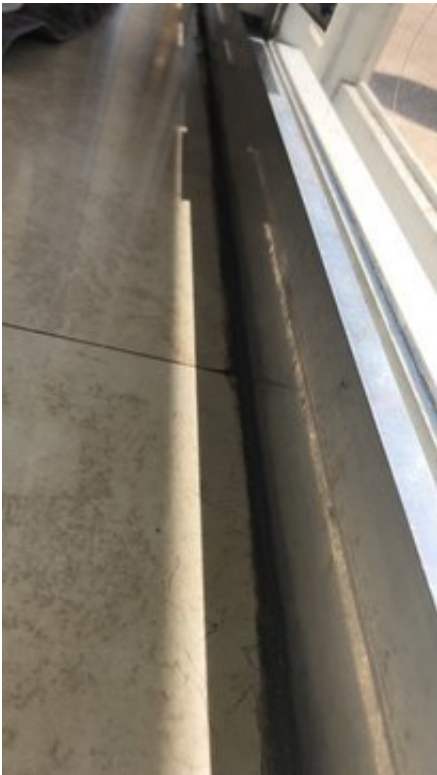
Shows evidence of visual mold growth on the floor and wall(s) on the living room by the backyard sliding door.

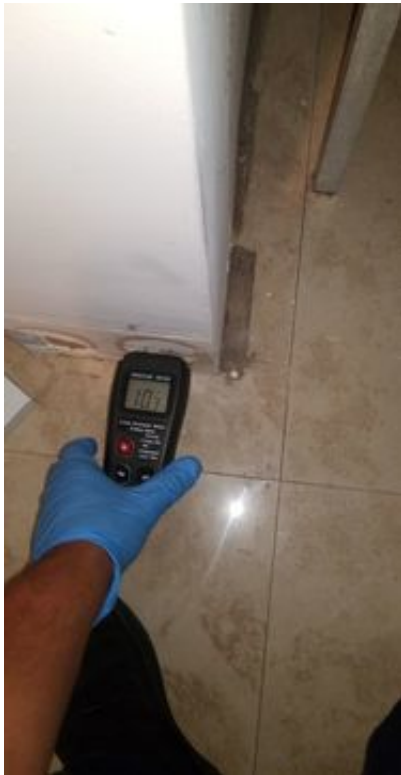
Shows moisture reading taken from the wall of the first central A/C unit closet where elevated moisture levels were noted upon inspection, using a Digital Moisture Meter.

****According to Florida State Guidelines for Mold Assessment and Remediation, mold growth present on central A/C unit(s), including intakes, coils, ventilation systems etc. must be removed by a State Licensed Mold Remediator and cannot be serviced by standard State Licensed A/C Technicians.**

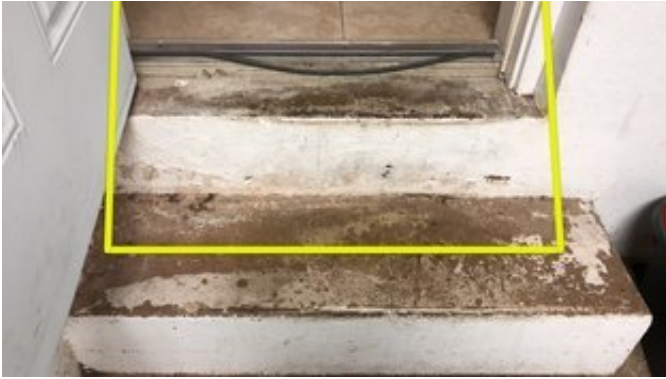
Shows discoloration evident of water damage as well as evidence of visual mold growth on the staircase by the gym entrance.

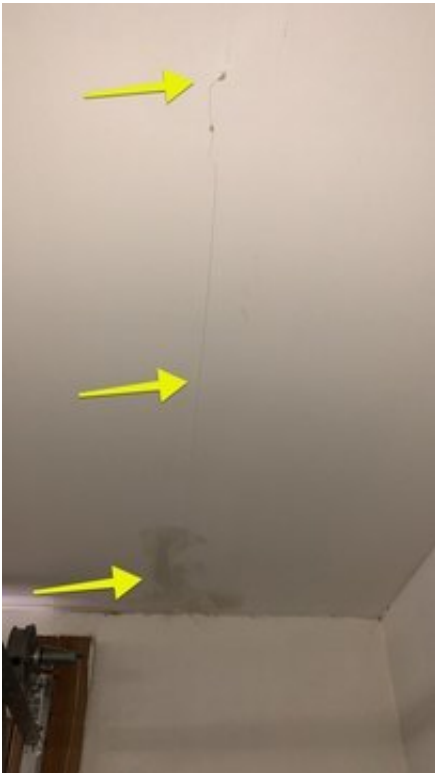
Shows hairline cracks present on the gym ceiling, providing conditions conducive to water damage and/or moisture intrusion.

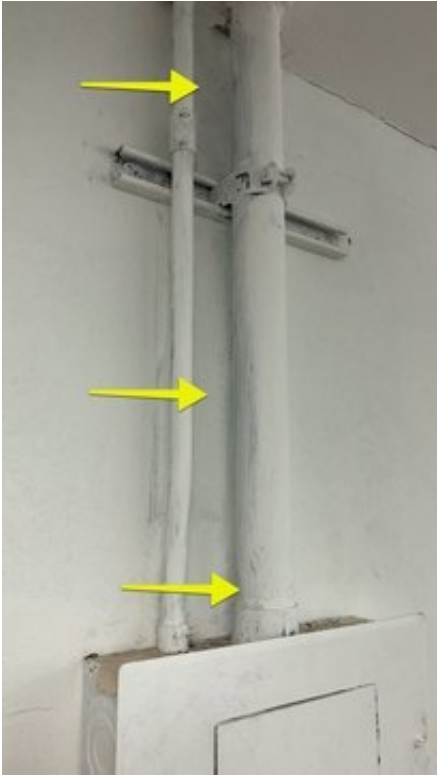
Shows discoloration evident of water damage on the gym wall(s).

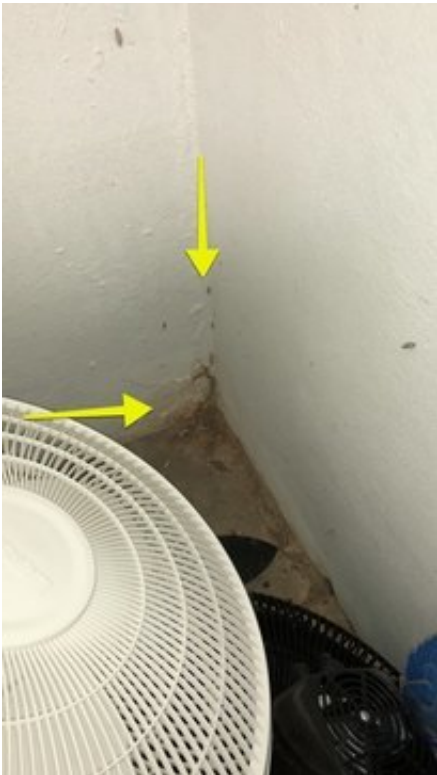
Shows discoloration evident of water damage on the gym wall(s) and/or floor.

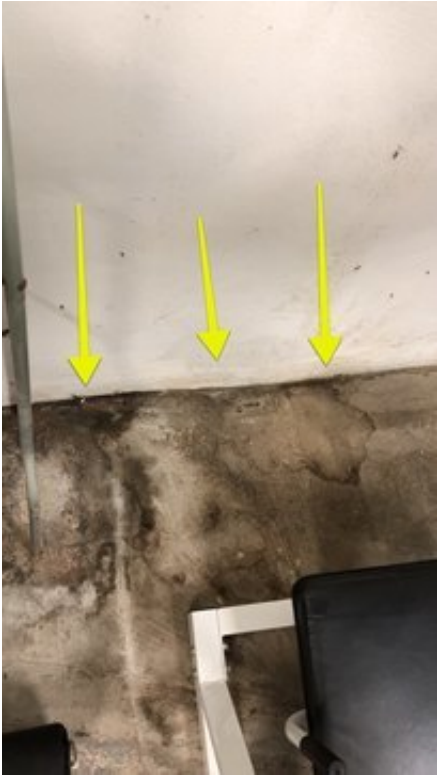
Shows discoloration evident of water damage as well as evidence of visual mold growth on the wall(s) and floor of the gym.

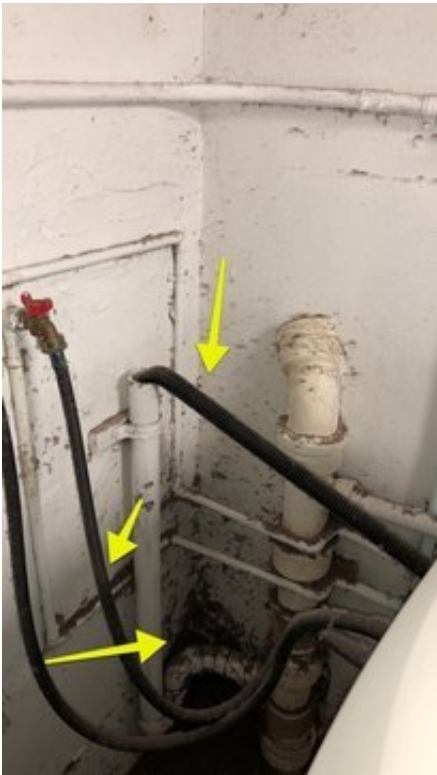
Shows discoloration evident of water damage as well as evidence of visual mold growth on floor, wall(s), and pipes located in the laundry room/gym.

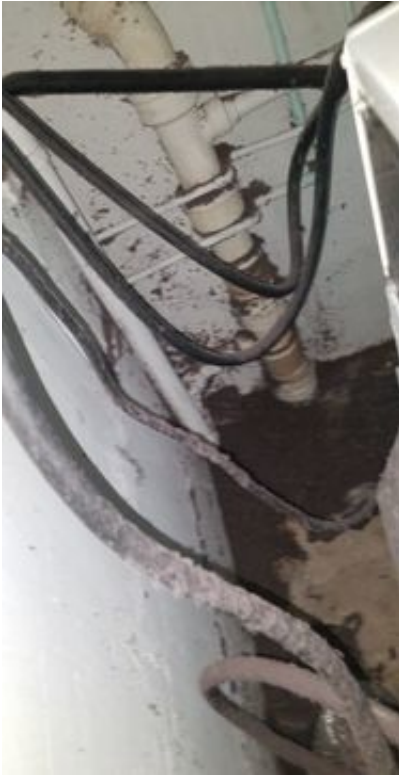
Shows evidence discoloration as well as evidence of visual mold growth throughout the pipes located in the laundry room/gym.

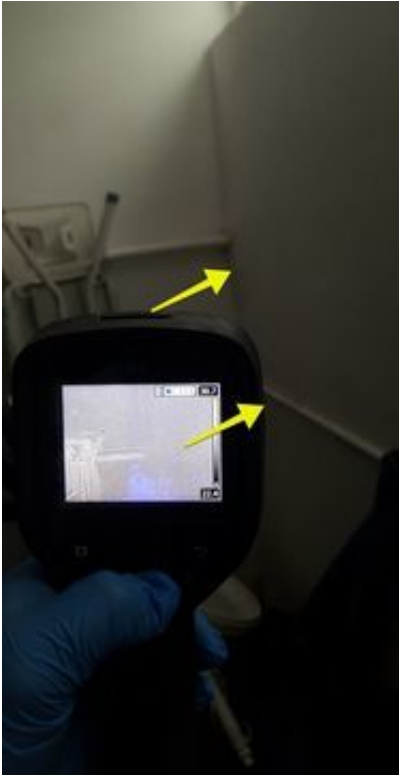
Shows Infrared Thermography Imaging being used throughout the wall(s) of the gym where elevated moisture levels were noted upon inspection.

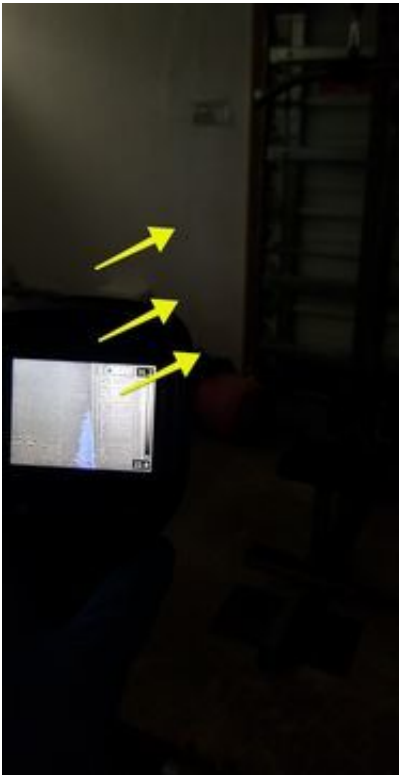
Shows Infrared Thermography Imaging being used throughout the wall(s) of the gym where elevated moisture levels were noted upon inspection.

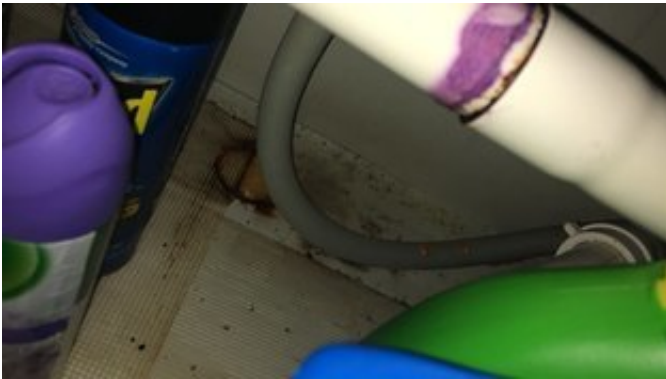
Shows discoloration evident of water damage as well of evidence of visual mold growth under the kitchen sink.

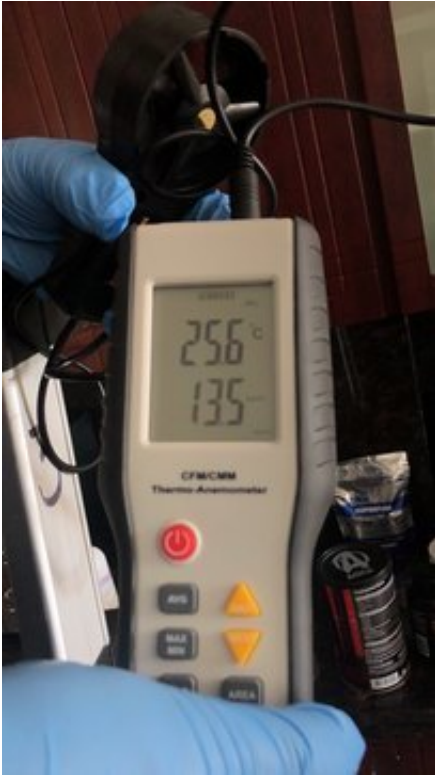
Shows a Thermo-Anemometer being used by the kitchen vent where temperature levels were noted within acceptable ranges and airflow levels were noted below acceptable ranges.

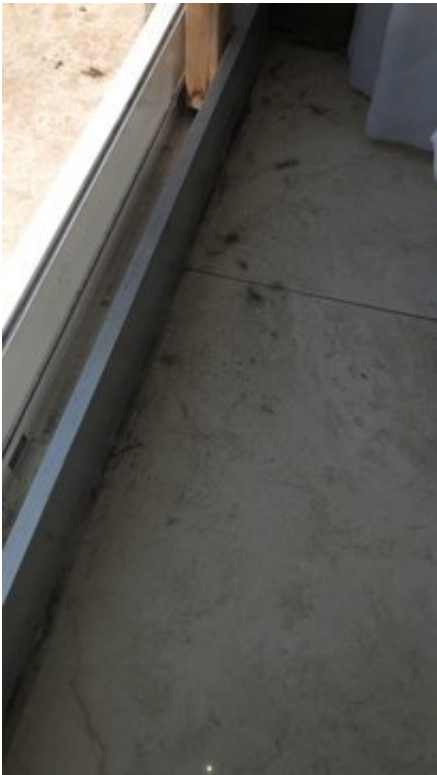
Shows evidence of visual mold growth on the floor and sliding door located in the master bedroom.

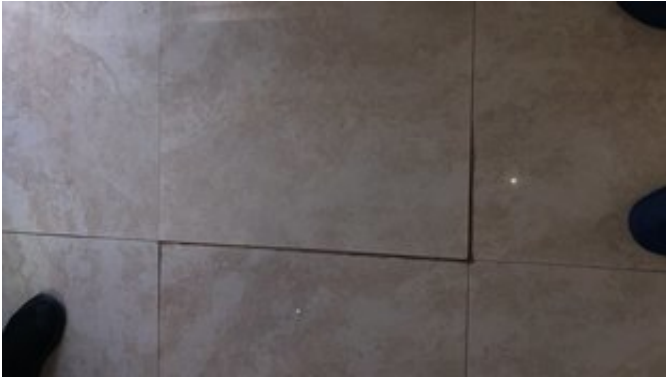
Shows warping evident of water damage as well as evidence of visual mold growth on the master bedroom floor and tile(s).

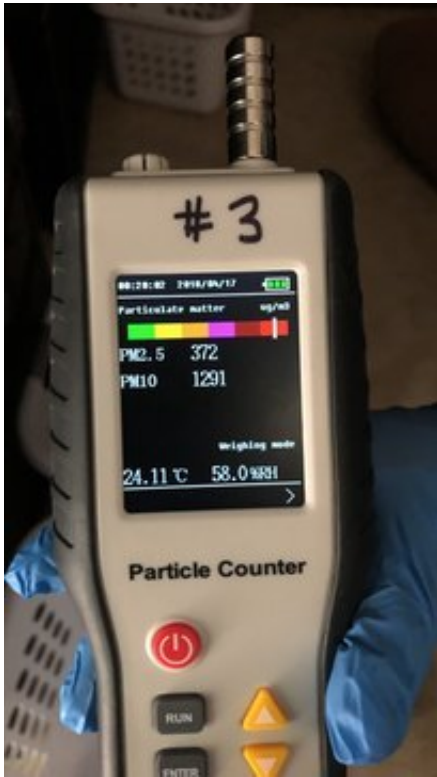
Shows particle count taken from the master bedroom where particle levels were noted highly elevated upon inspection, using a Digital Air Particle Counter.

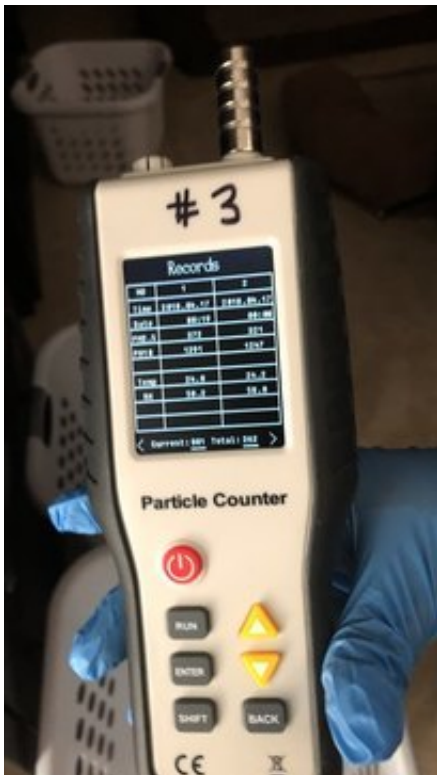
Shows particle count taken from the master bedroom where particle levels were noted highly elevated upon inspection, using a Digital Air Particle Counter.

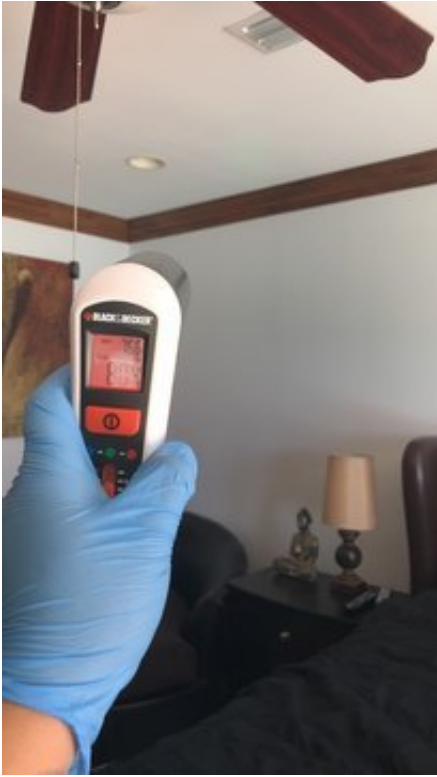
Shows a Digital LED Color Thermometer being used on the wall(s) of the master bedroom where temperature levels were noted slightly elevated upon inspection.

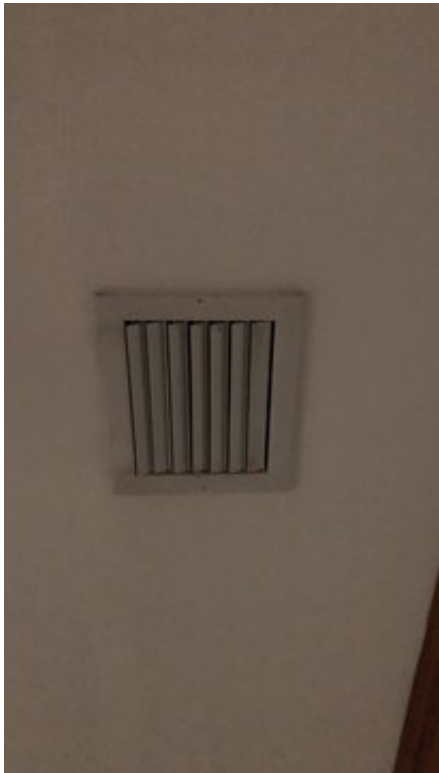
Shows evidence of visual mold growth on the the first guest bedroom vent.

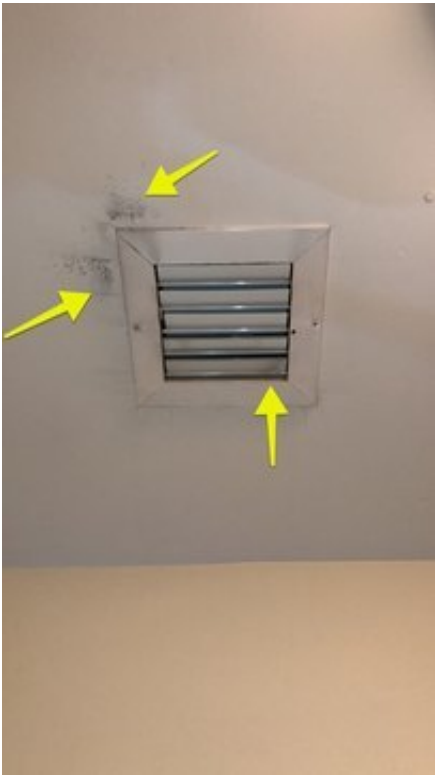
Shows evidence of visual mold growth on the first guest bathroom vent.

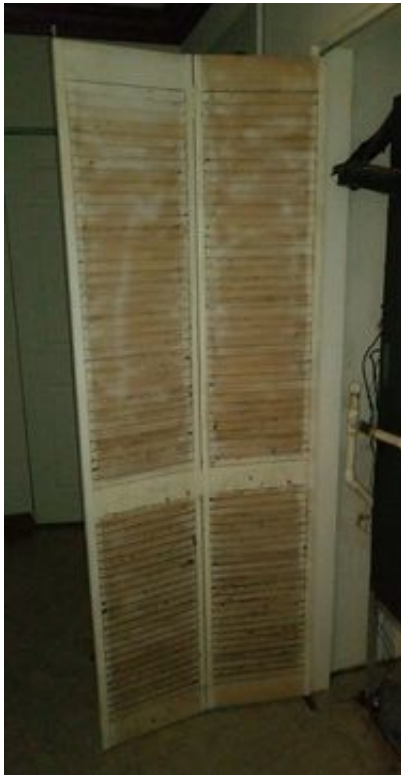
Shows discoloration evident of water damage of the door of the second central A/C unit closet.

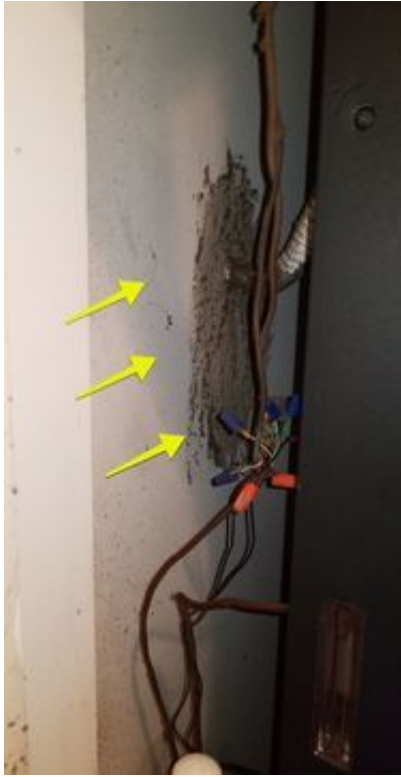
Shows evidence of visual mold growth throughout the wall(s) of the second central A/C unit closet.

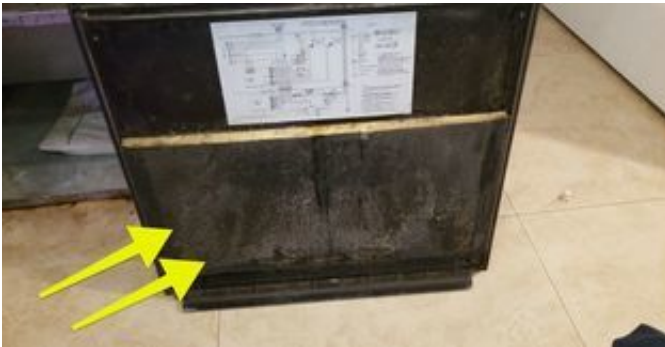
Shows discoloration evident of water damage on the second central A/C unit.

**According to Florida State Guidelines for Mold Assessment and Remediation, mold growth present on central A/C unit(s), including intakes, coils, ventilation systems etc. must be removed by a State Licensed Mold Remediator and cannot be serviced by standard State Licensed A/C Technicians.

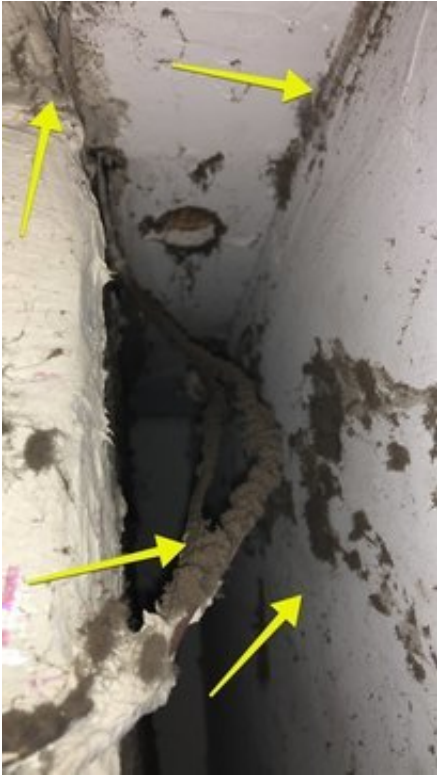
Shows evidence of visual mold growth throughout the inside of the second central A/C unit closet.

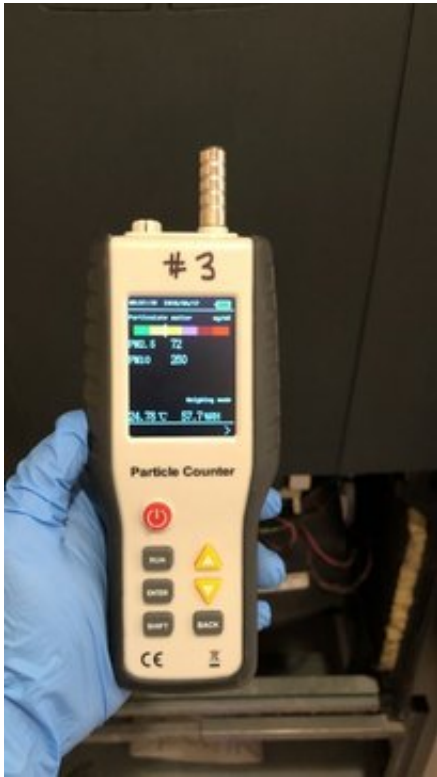
Shows an elevated particle count present in the second central A/C unit closet upon inspection using a Digital Air Particle Counter.

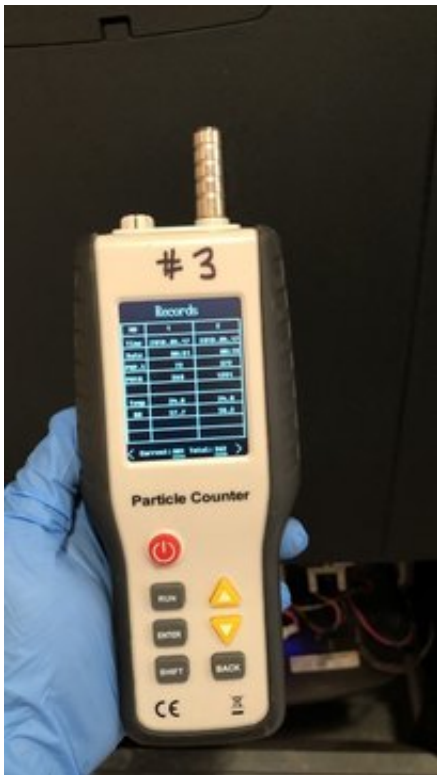
Shows an elevated particle count present in the second central A/C unit closet upon inspection using a Digital Air Particle Counter.

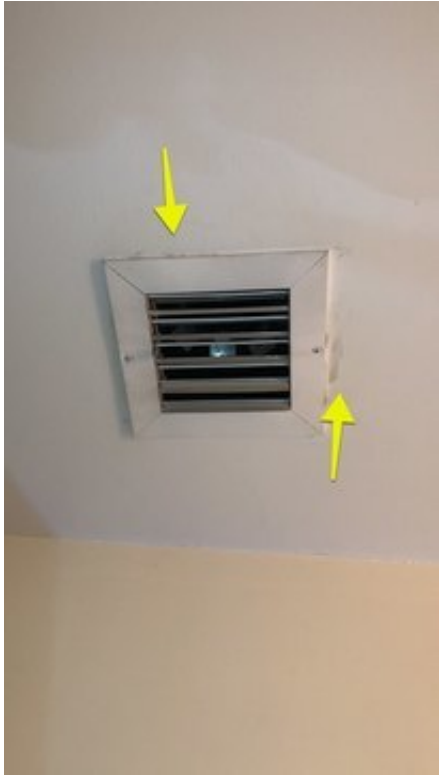
Shows evidence of visual mold growth throughout the second guest bathroom vent.

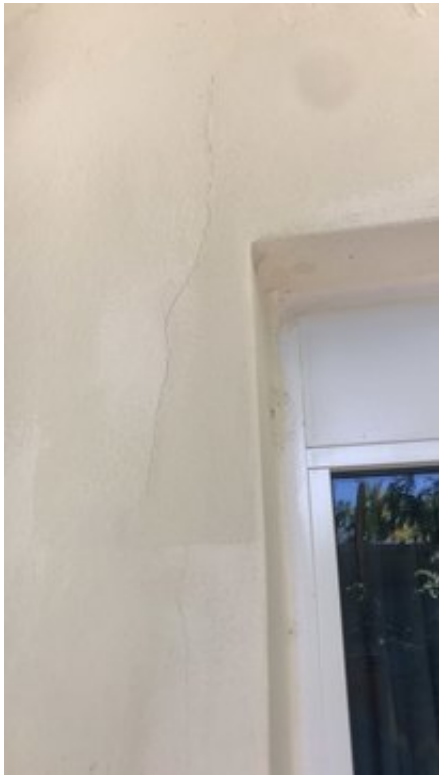
Shows crack(s) and/or gap(s) throughout the exterior wall corresponding to the kitchen providing conditions conducive to water intrusion.

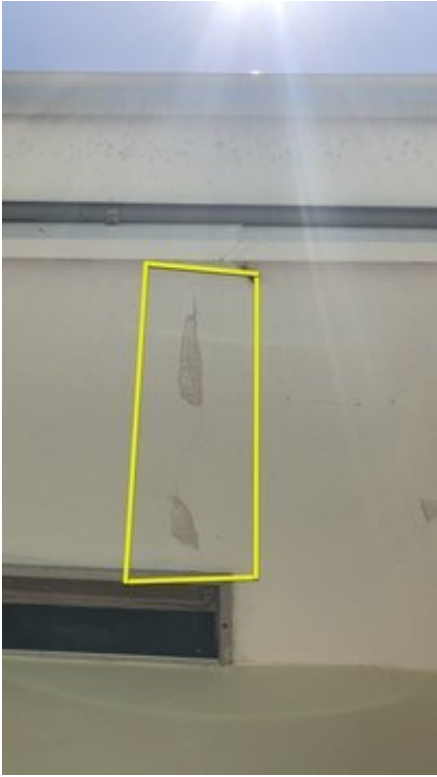
Shows crack(s) and/or gap(s) throughout the exterior wall corresponding to the kitchen providing conditions conducive to water intrusion.

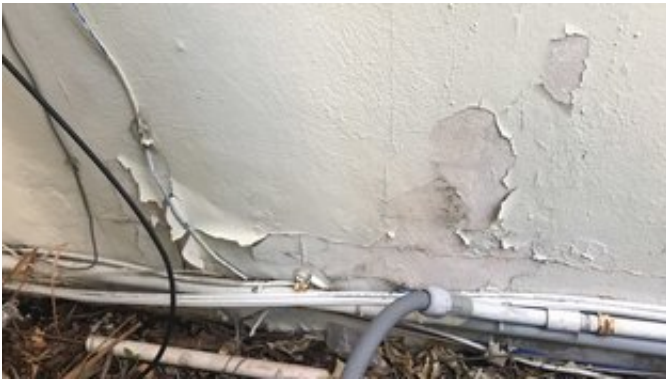
Shows discoloration as well as paint peeling, cracking and/or bubbling evident of water damage around the exterior wall of the property corresponding to th kitchen wall.

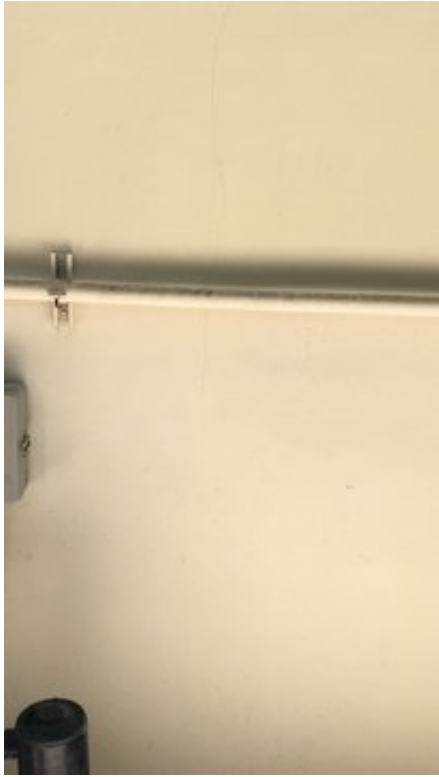
Shows crack(s) present on the exterior wall of the property providing conditions conducive to water intrusion.

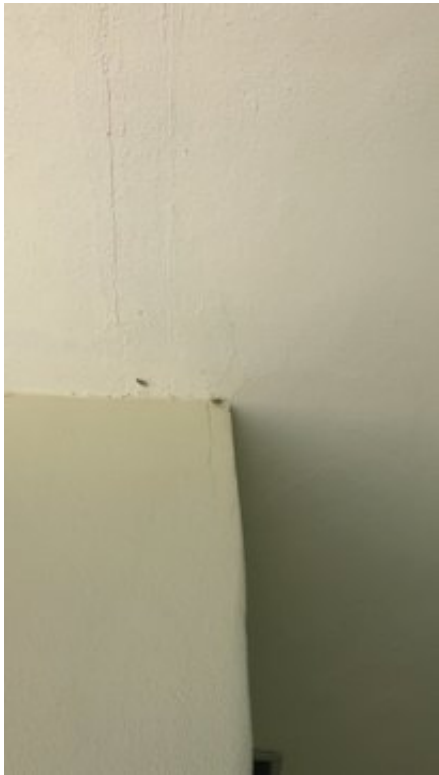
Shows crack(s) and/or gap(s) throughout the exterior wall by the backyard providing conditions conducive to water intrusion.

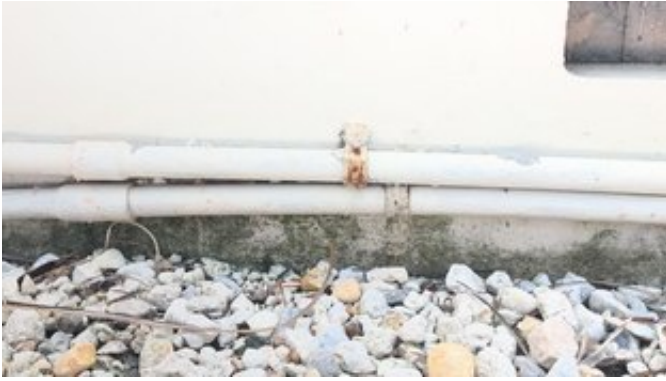
Shows discoloration as well as paint peeling, cracking and/or bubbling evident of water damage around the exterior wall and pipes.

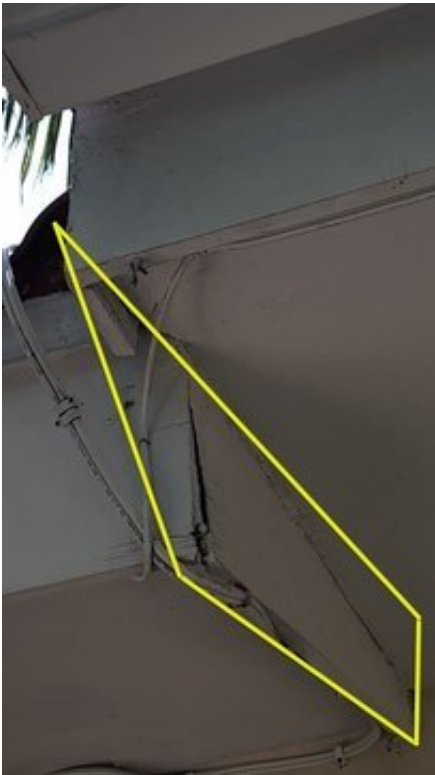
Shows crack(s) and/or gap(s) throughout the exterior wall providing conditions conducive to water intrusion.

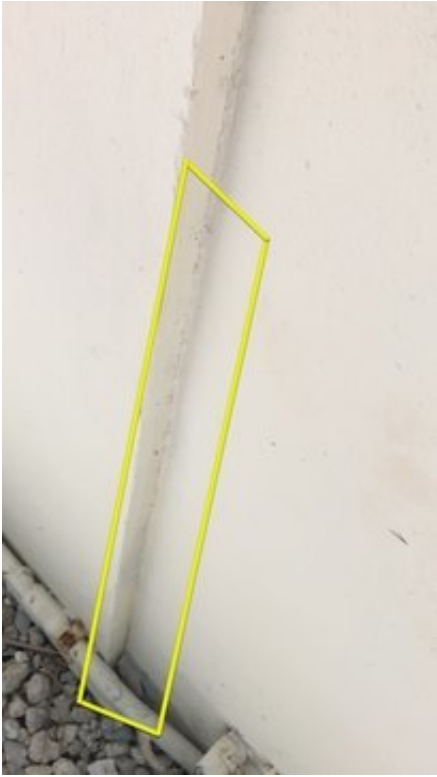
Shows crack(s) and/or gap(s) throughout the exterior wall providing conditions conducive to water intrusion.

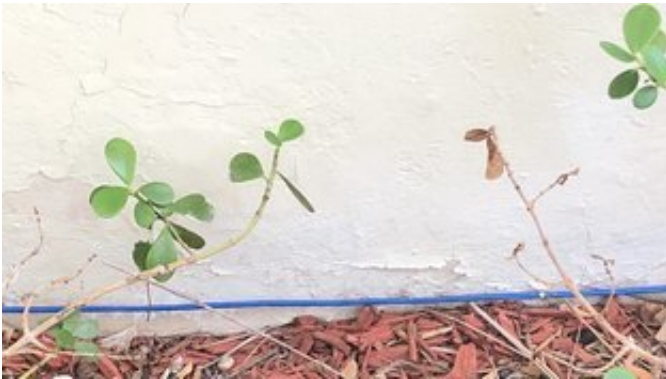
Shows crack(s) and/or gap(s) throughout the exterior wall providing conditions conducive to water intrusion.

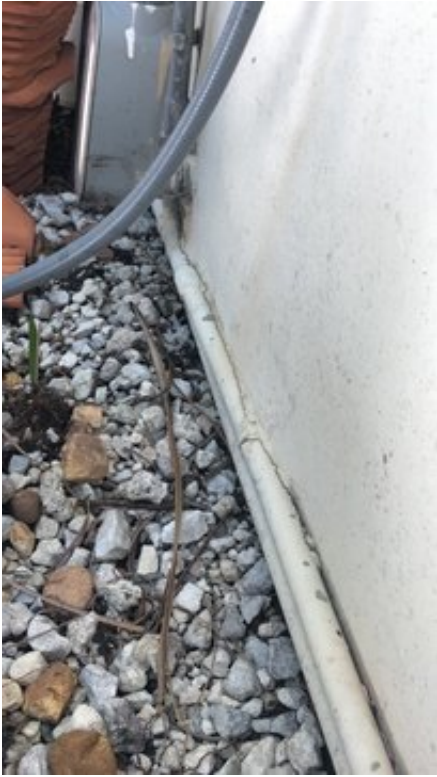
Shows crack(s) and/or gap(s) throughout the exterior wall providing conditions conducive to water intrusion.

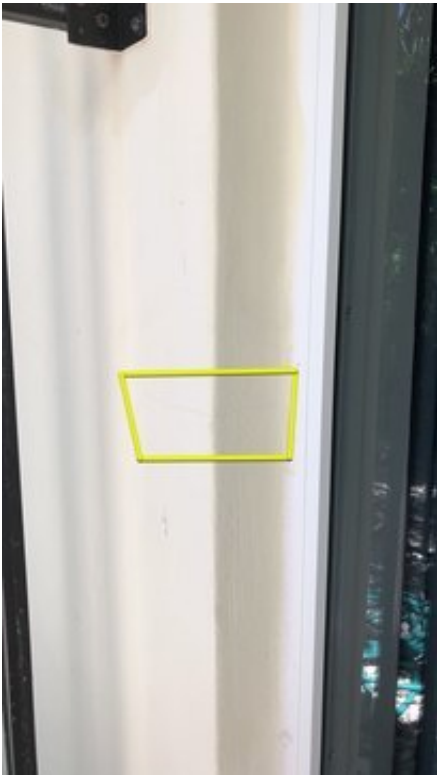
Shows crack(s) and/or gap(s) throughout the exterior wall providing conditions conducive to water intrusion.

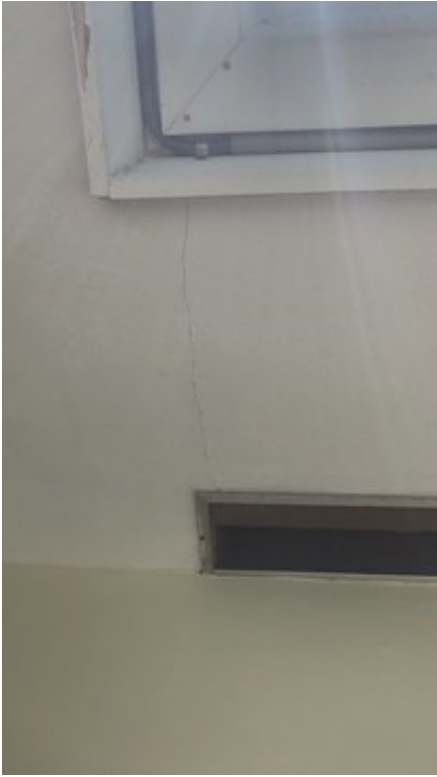
Shows a crack and/or gap throughout the exterior ceiling and/or wall by the backyard sliding door providing conditions conducive to water intrusion.

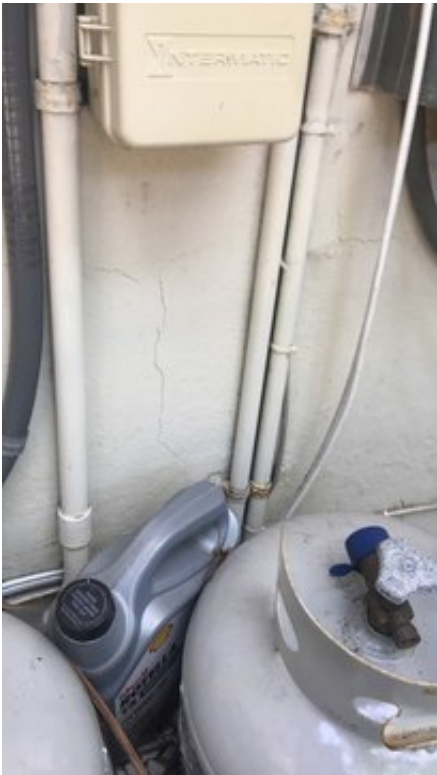
Shows crack(s) and/or gap(s) throughout the exterior wall providing conditions conducive to water intrusion.

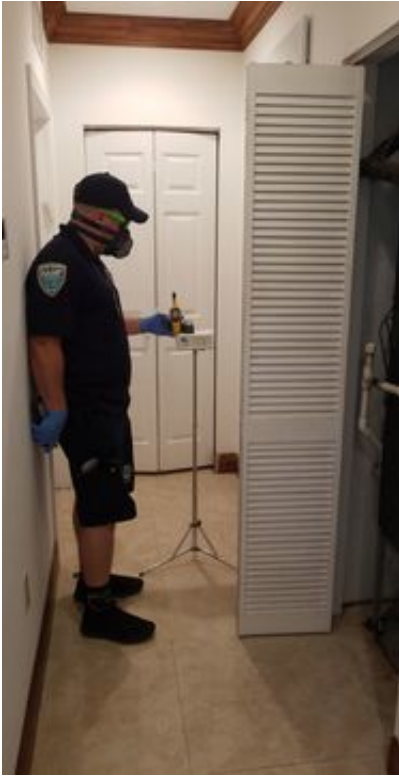
Shows air sampling being taken from the hallway, where elevated levels of airborne mold spores were present throughout, as confirmed through lab results.
