MOLD ASSESSMENT REPORT & REMEDIATION PROCESS OF:

**1190 Bay Drive
Miami Beach, FL 33141**

Report Date: 04/18/18

PREPARED BY ALBERTO RIVERA & MIAMI MOLD SPECIALIST

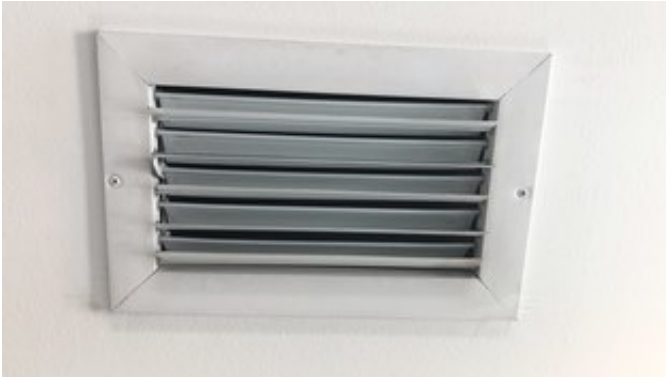
Shows the dining room vent upon inspection.

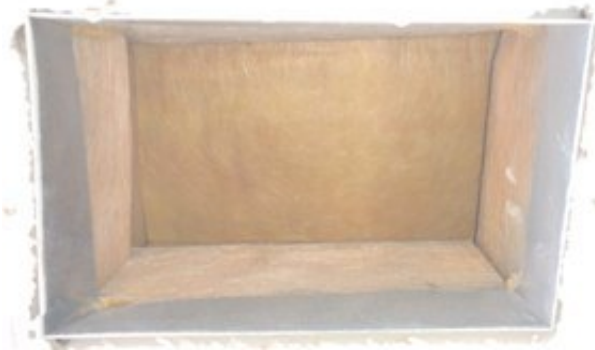
Shows the dining room vent area upon inspection.

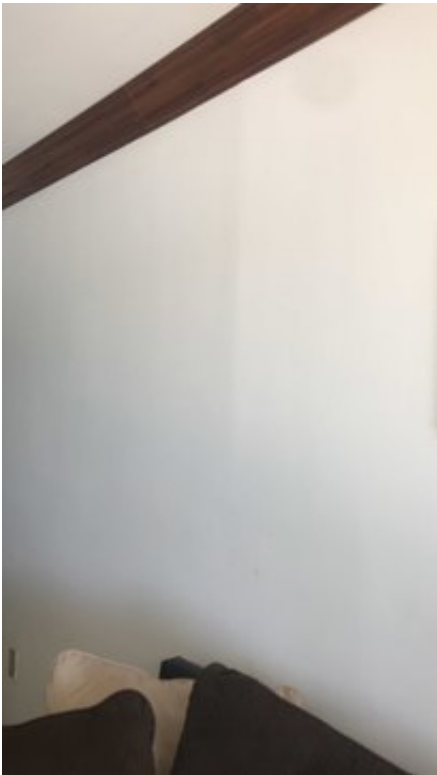
Shows discoloration as well as paint bubbling evident of water damage on the living room wall.

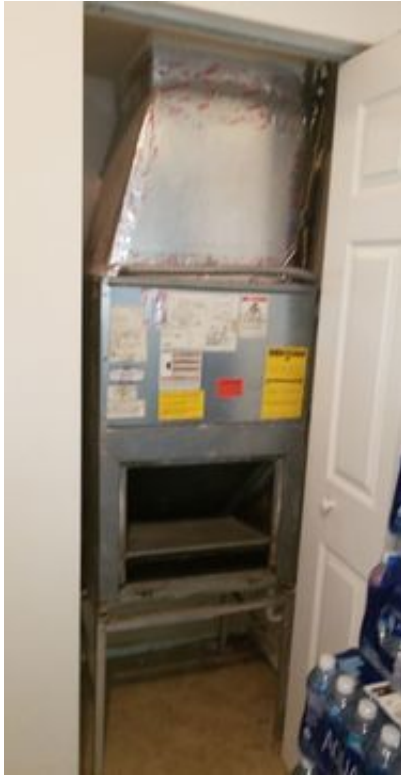
Shows the first central A/C unit closet located in the gym.

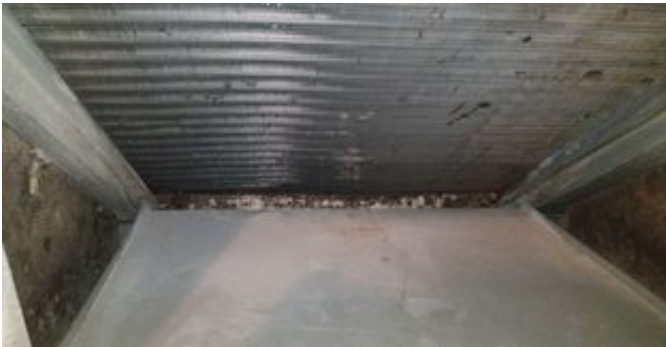
Shows evidence of mold growth on the coils of the first central A/C unit.

**According to Florida State Guidelines for Mold Assessment and Remediation, mold growth present on central A/C unit(s), including intakes, coils, ventilation systems etc. must be removed by a State Licensed Mold Remediator and cannot be serviced by standard State Licensed A/C Technicians.

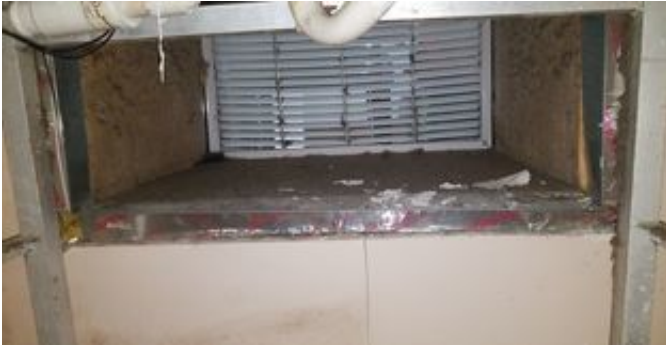
Shows evidence of mold growth throughout the first central A/C unit intake.

**According to Florida State Guidelines for Mold Assessment and Remediation, mold growth present on central A/C unit(s), including intakes, coils, ventilation systems etc. must be removed by a State Licensed Mold Remediator and cannot be serviced by standard State Licensed A/C Technicians.

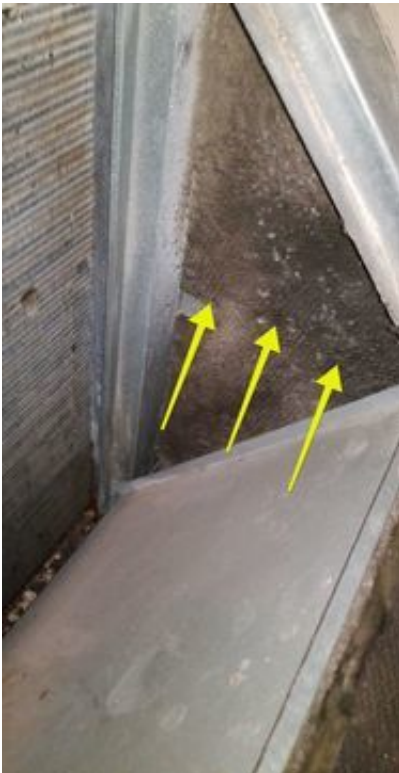
Shows evidence of visual mold growth throughout the first central A/C unit intake.

**According to Florida State Guidelines for Mold Assessment and Remediation, mold growth present on central A/C unit(s), including intakes, coils, ventilation systems etc. must be removed by a State Licensed Mold Remediator and cannot be serviced by standard State Licensed A/C Technicians.

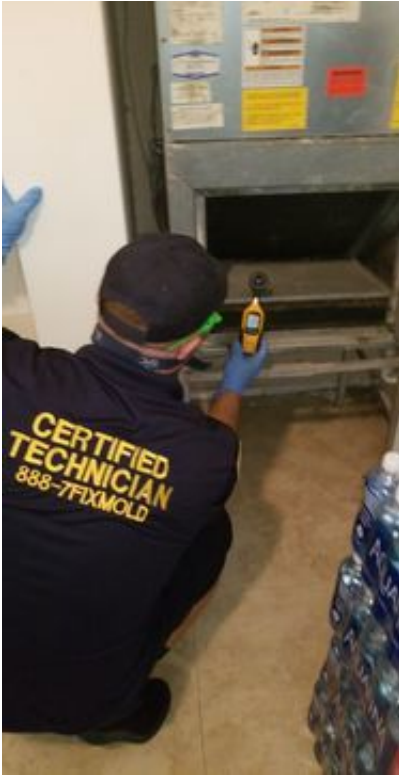
Shows a Digital Anemometer being used by the first central A/C unit closet.

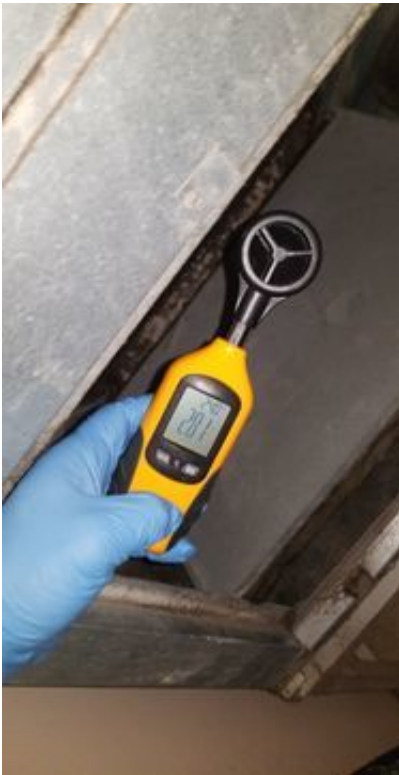
Shows a Digital Airflow Meter being used by the first central A/C unit where airflow levels were low upon inspection, likely a result of clogged coils.

****According to Florida State Guidelines for Mold Assessment and Remediation, mold growth present on central A/C unit(s), including intakes, coils, ventilation systems etc. must be removed by a State Licensed Mold Remediator and cannot be serviced by standard State Licensed A/C Technicians.**

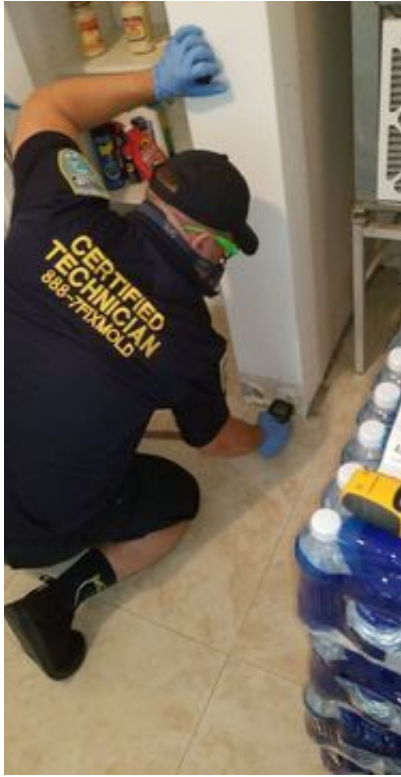
Shows a Digital Moisture Meter being used throughout the wall(s) of the first central A/C unit closet.

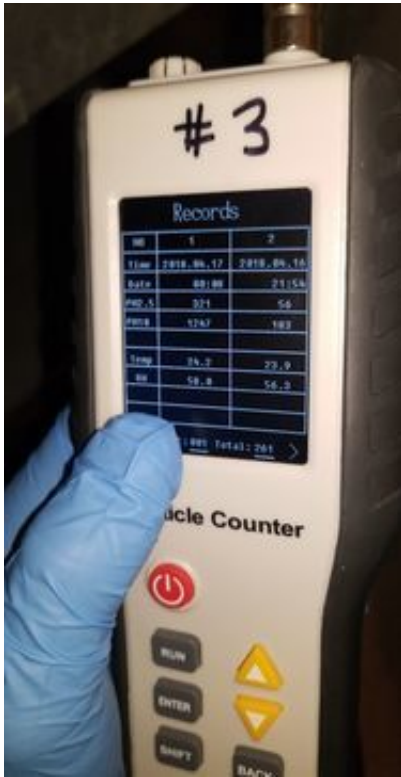
Shows a highly elevated particle count present in the first central A/C unit closet upon inspection using a Digital Air Particle Counter.

**According to Florida State Guidelines for Mold Assessment and Remediation, mold growth present on central A/C unit(s), including intakes, coils, ventilation systems etc. must be removed by a State Licensed Mold Remediator and cannot be serviced by standard State Licensed A/C Technicians.

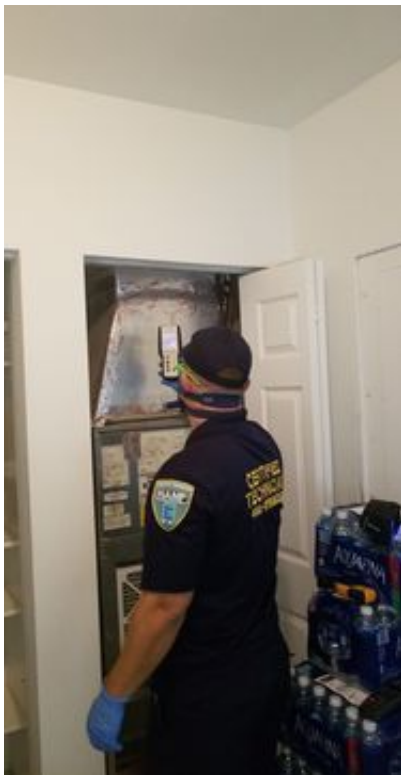
Shows a Digital Air Particle Counter being used by the first central A/C unit closet.

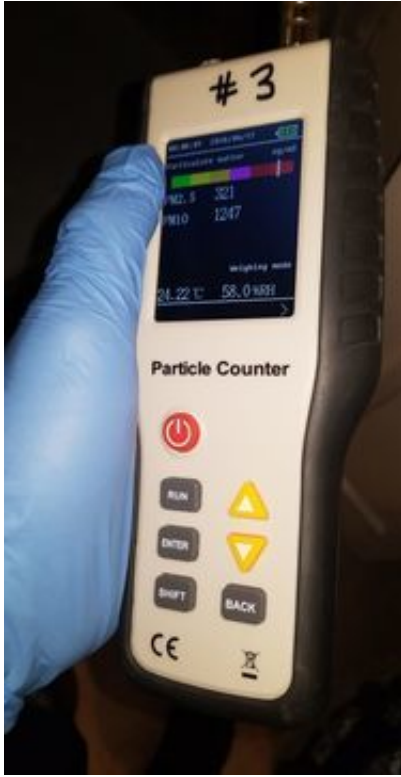
Shows a highly elevated particle count present in the central A/C unit closet upon inspection using a Digital Air Particle Counter.

**According to Florida State Guidelines for Mold Assessment and Remediation, mold growth present on central A/C unit(s), including intakes, coils, ventilation systems etc. must be removed by a State Licensed Mold Remediator and cannot be serviced by standard State Licensed A/C Technicians.

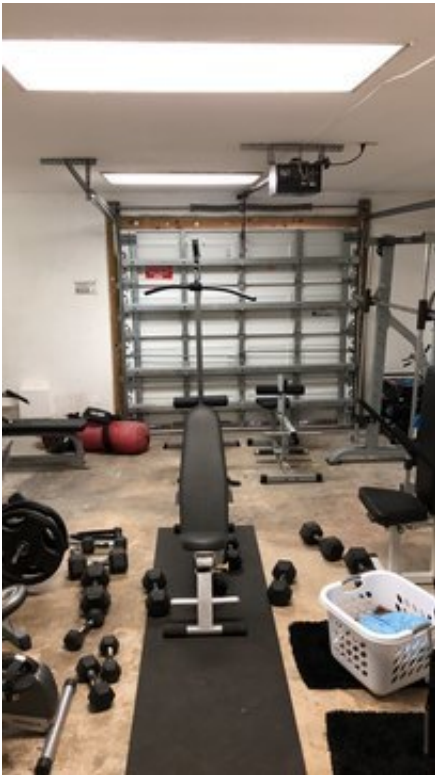
Shows the gym upon inspection.

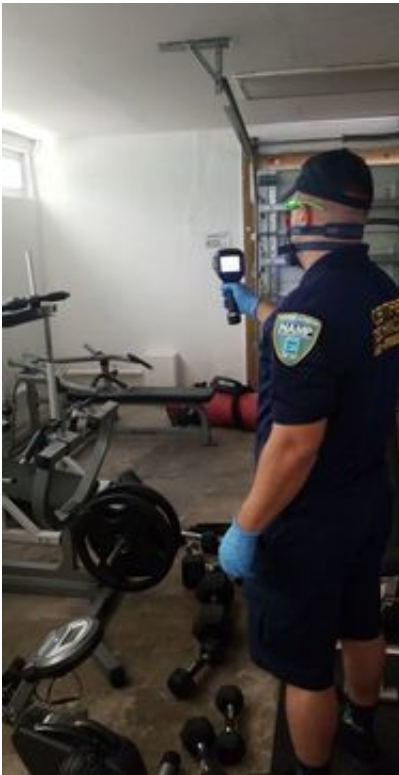
Shows Infrared Thermography Imaging being used on the wall(s) of the gym.

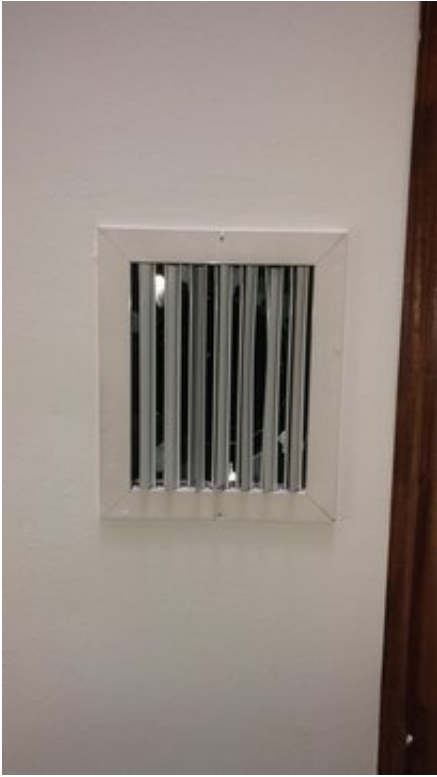
Shows a Thermo-Anemometer being used by the kitchen vent.

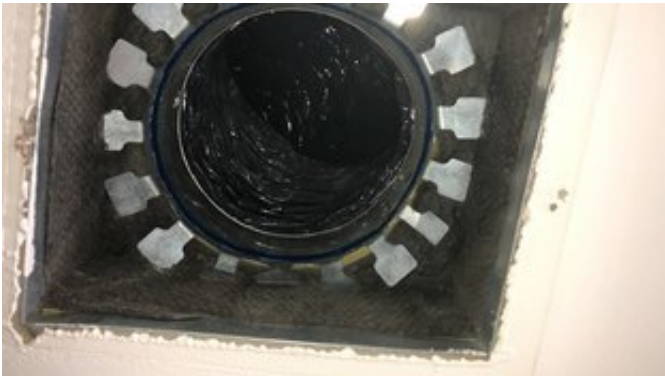
Shows evidence of visual mold growth throughout the kitchen vent/ductwork.

**According to Florida State Guidelines for Mold Assessment and Remediation, mold growth present on central A/C unit(s), including intakes, coils, ventilation systems etc. must be removed by a State Licensed Mold Remediator and cannot be serviced by standard State Licensed A/C Technicians.

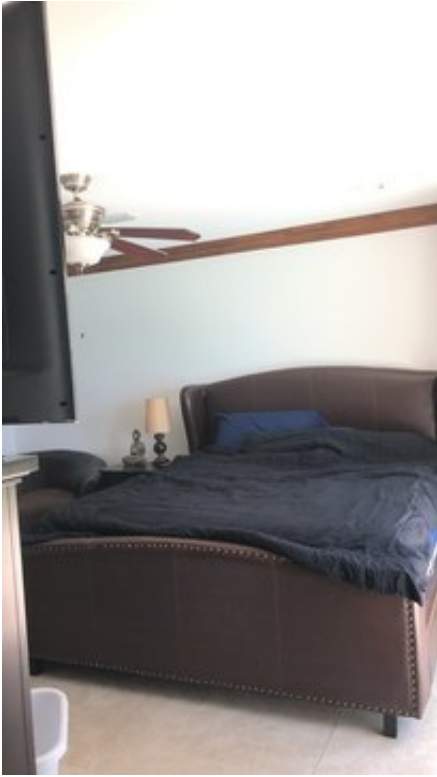
Shows evidence of visual mold growth on the floor and sliding door located in the master bedroom.

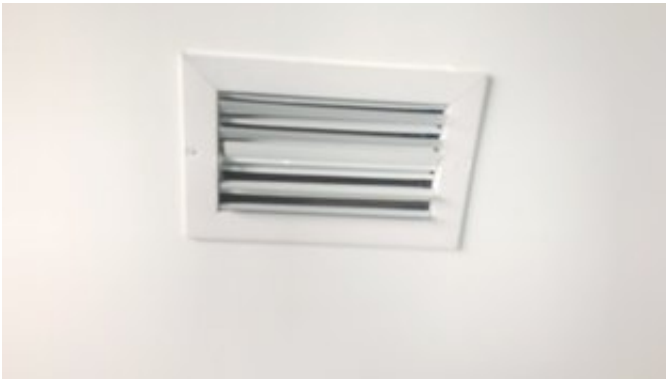
Shows the master bedroom vent upon inspection.

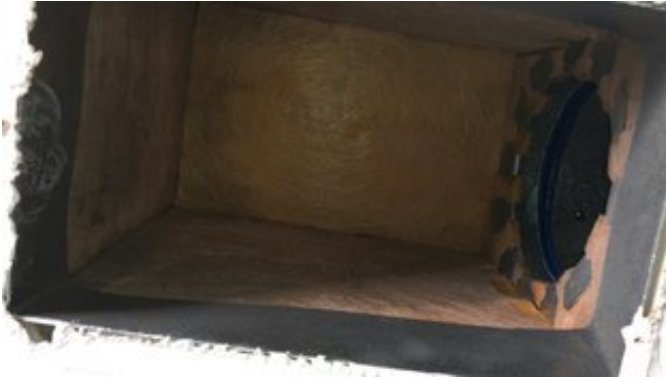
Shows discoloration throughout the master bedroom vent/ductwork.

**According to Florida State Guidelines for Mold Assessment and Remediation, mold growth present on central A/C unit(s), including intakes, coils, ventilation systems etc. must be removed by a State Licensed Mold Remediator and cannot be serviced by standard State Licensed A/C Technicians.

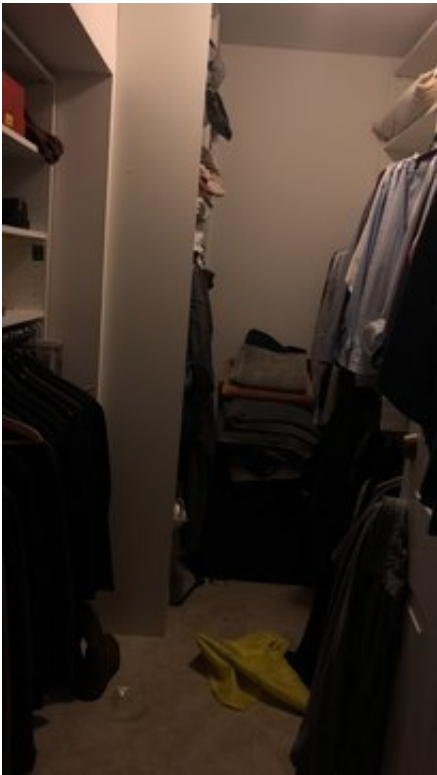
Shows the master bedroom closet upon inspection.

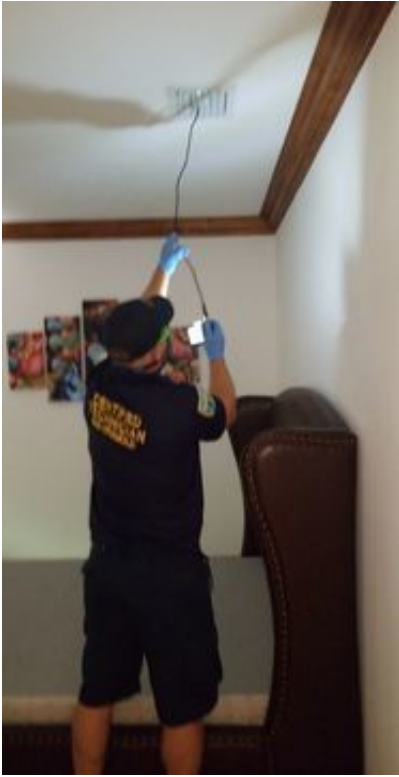
Shows an LED Fiber Optic Snake Camera being used throughout the first guest bedroom vent.

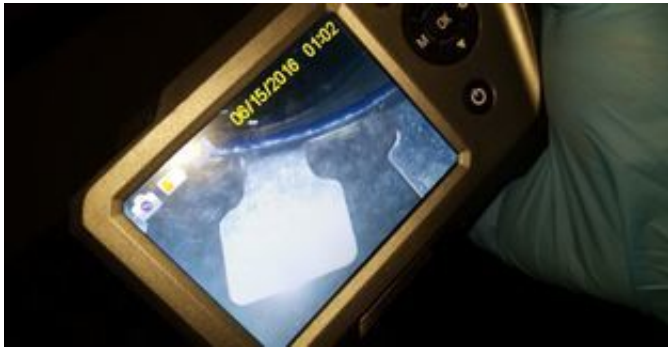
Shows discoloration throughout the first guest bedroom vent using an LED Fiber Optic Snake Camera.

**According to Florida State Guidelines for Mold Assessment and Remediation, mold growth present on central A/C unit(s), including intakes, coils, ventilation systems etc. must be removed by a State Licensed Mold Remediator and cannot be serviced by standard State Licensed A/C Technicians.

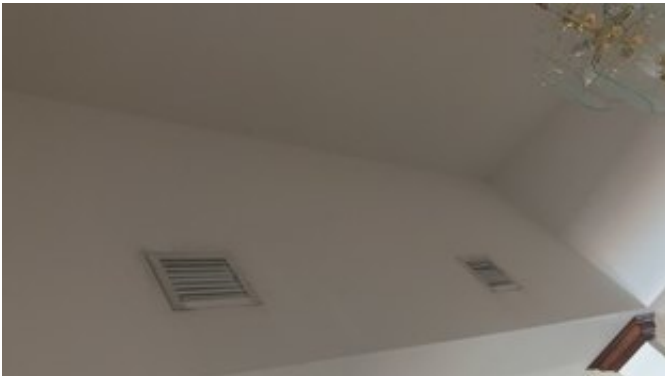
Show discoloration on and surrounding the family room vent(s).

**According to Florida State Guidelines for Mold Assessment and Remediation, mold growth present on central A/C unit(s), including intakes, coils, ventilation systems etc. must be removed by a State Licensed Mold Remediator and cannot be serviced by standard State Licensed A/C Technicians.

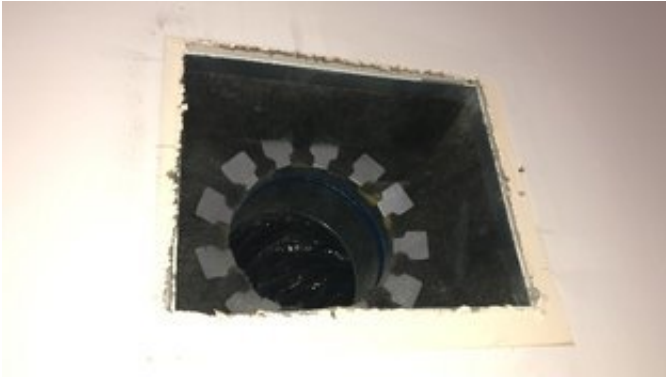
Show evidence of visual mold growth throughout the family room vent/ductwork.

**According to Florida State Guidelines for Mold Assessment and Remediation, mold growth present on central A/C unit(s), including intakes, coils, ventilation systems etc. must be removed by a State Licensed Mold Remediator and cannot be serviced by standard State Licensed A/C Technicians.

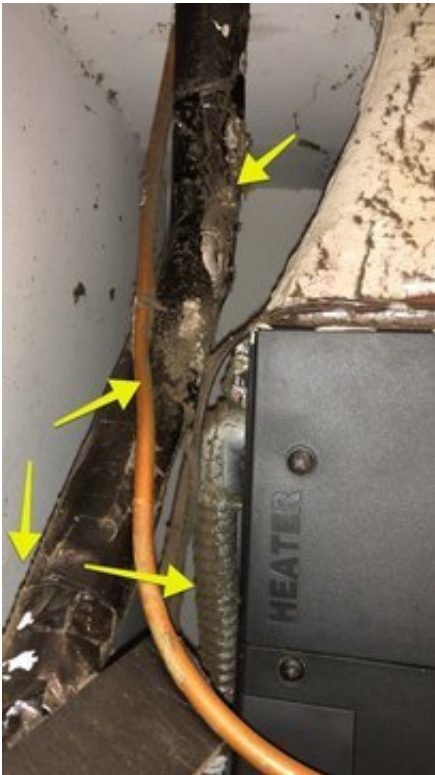
Shows evidence of visual mold growth throughout the wall(s) and coils of the second central A/C unit.

**According to Florida State Guidelines for Mold Assessment and Remediation, mold growth present on central A/C unit(s), including intakes, coils, ventilation systems etc. must be removed by a State Licensed Mold Remediator and cannot be serviced by standard State Licensed A/C Technicians.

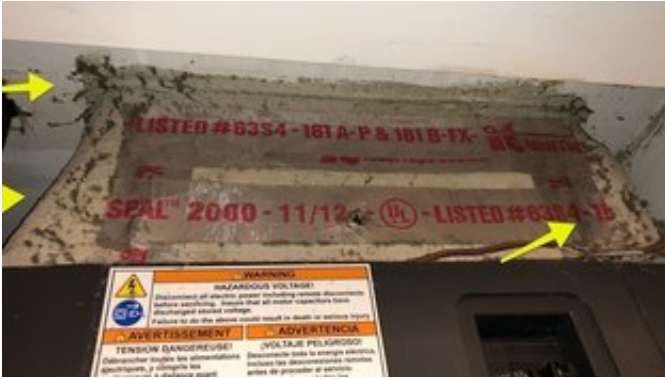
Shows evidence of visual mold growth throughout the wall(s) of the second central A/C unit closet.

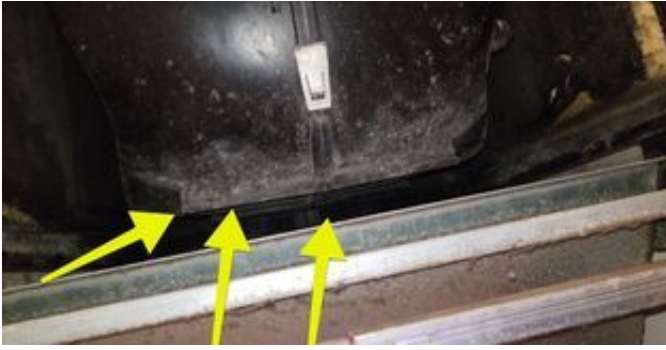
Shows evidence of visual mold growth throughout the second central A/C unit closet.

**According to Florida State Guidelines for Mold Assessment and Remediation, mold growth present on central A/C unit(s), including intakes, coils, ventilation systems etc. must be removed by a State Licensed Mold Remediator and cannot be serviced by standard State Licensed A/C Technicians.

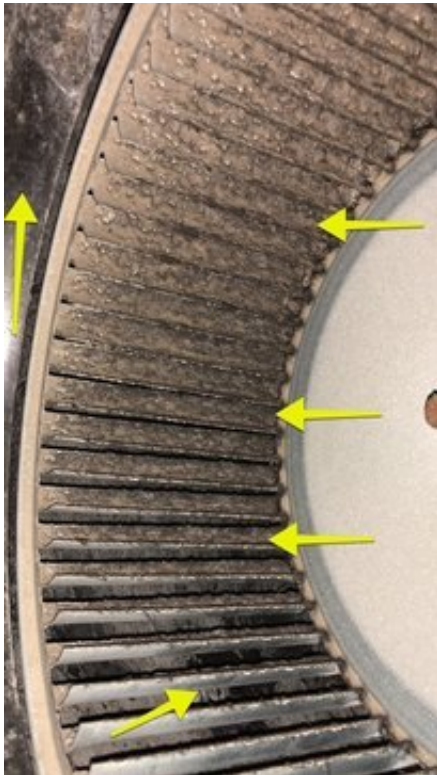
Shows evidence of visual mold growth throughout the coils of the second central A/C unit.

**According to Florida State Guidelines for Mold Assessment and Remediation, mold growth present on central A/C unit(s), including intakes, coils, ventilation systems etc. must be removed by a State Licensed Mold Remediator and cannot be serviced by standard State Licensed A/C Technicians.

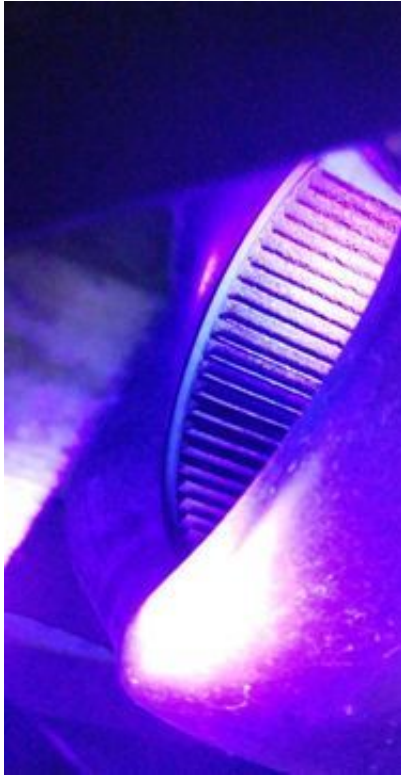
Shows evidence of visual mold growth throughout the coils of the second central A/C unit using an LED UV Flashlight.

**According to Florida State Guidelines for Mold Assessment and Remediation, mold growth present on central A/C unit(s), including intakes, coils, ventilation systems etc. must be removed by a State Licensed Mold Remediator and cannot be serviced by standard State Licensed A/C Technicians.

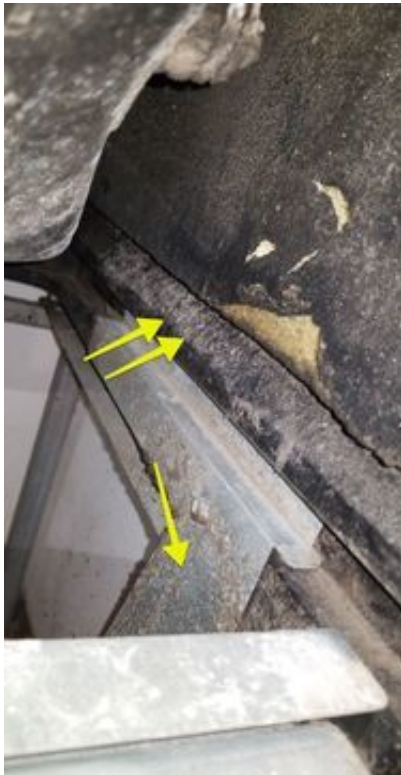
Shows evidence of visual mold growth throughout the inside of the second central A/C unit closet.

**According to Florida State Guidelines for Mold Assessment and Remediation, mold growth present on central A/C unit(s), including intakes, coils, ventilation systems etc. must be removed by a State Licensed Mold Remediator and cannot be serviced by standard State Licensed A/C Technicians.

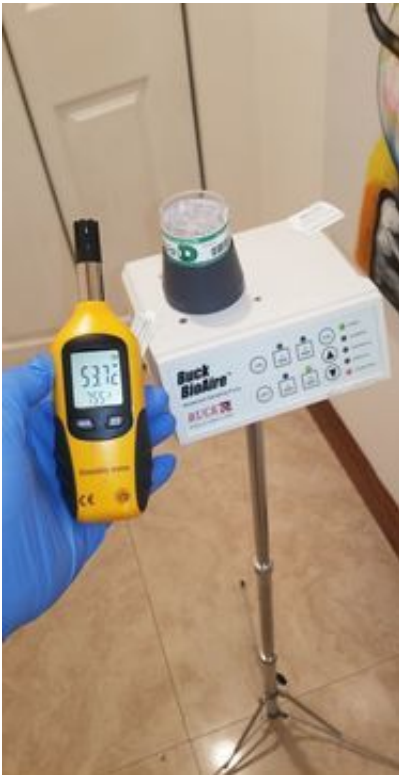
Shows air sampling being taken from the hallway, where elevated levels of airborne mold spores were present throughout, as confirmed through lab results.
